# Home Report

FLAT 1/2  
120 BOWMAN STREET  
GLASGOW  
G42 8LG

# Energy Performance Certificate (EPC)

FLAT 1/2, 120 BOWMAN STREET, GLASGOW, G42 8LG

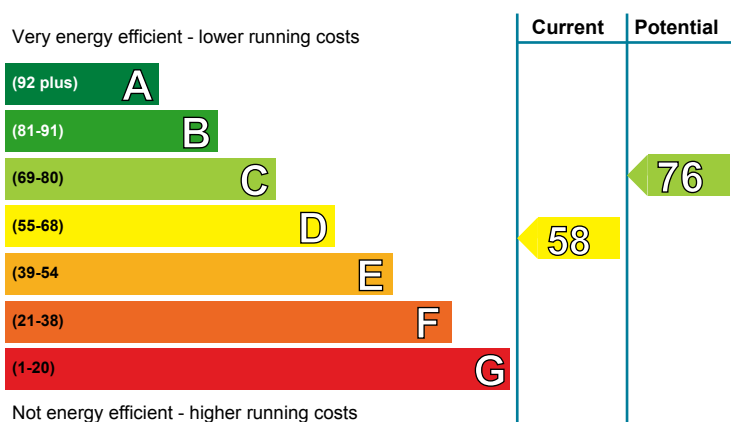
## Energy Efficiency Rating

This graph shows the current efficiency of your home, taking into account both energy efficiency and fuel costs. The higher this rating, the lower your fuel bills are likely to be.

Your current rating is **band D (58)**. The average rating for EPCs in Scotland is **band D (61)**.

The potential rating shows the effect of undertaking all of the improvement measures listed within your recommendations report.

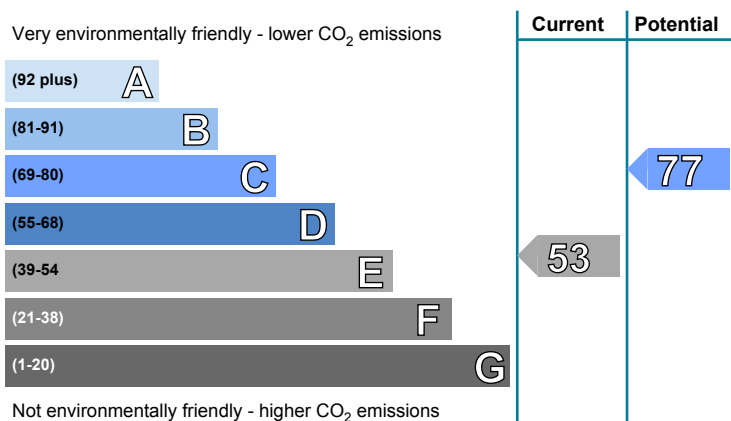
## Environmental Impact (CO<sub>2</sub>) Rating

This graph shows the effect of your home on the environment in terms of carbon dioxide (CO<sub>2</sub>) emissions. The higher the rating, the less impact it has on the environment.

Your current rating is **band E (53)**. The average rating for EPCs in Scotland is **band D (59)**.

The potential rating shows the effect of undertaking all of the improvement measures listed within your recommendations report.
