Home Report

FLAT
3 COTTAGE 5 EBENEZER
FAITH AVENUE
QUARRIERS VILLAGE
PA11 3TF

Energy Performance Certificate (EPC)

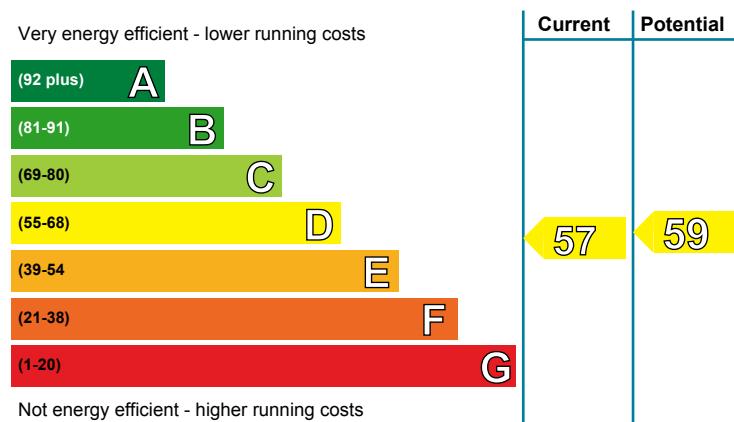
Energy Efficiency Rating

This graph shows the current efficiency of your home, taking into account both energy efficiency and fuel costs. The higher this rating, the lower your fuel bills are likely to be.

Your current rating is **band D (57)**. The average rating for EPCs in Scotland is **band D (61)**.

The potential rating shows the effect of undertaking all of the improvement measures listed within your recommendations report.

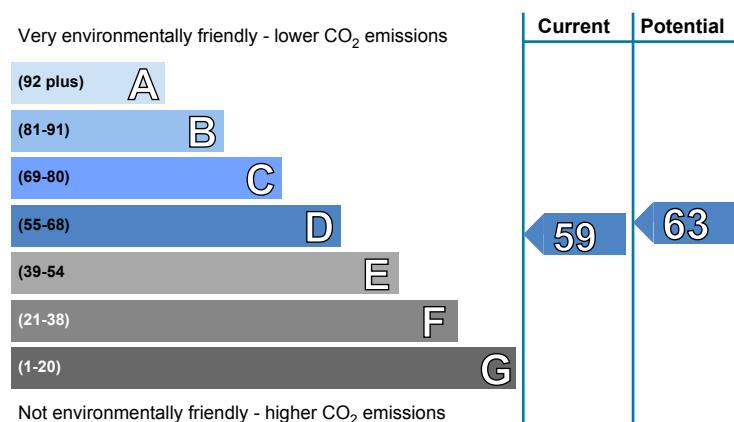
Environmental Impact (CO₂) Rating

This graph shows the effect of your home on the environment in terms of carbon dioxide (CO₂) emissions. The higher the rating, the less impact it has on the environment.

The potential rating shows the effect of undertaking all of the improvement measures listed within your recommendations report.
