Walker Fraser Steele Chartered Surveyors

80 SEIL DRIVE
GLASGOW
G44 5EA

Energy Performance Certificate

80 SEIL DRIVE, GLASGOW, G44 5EA

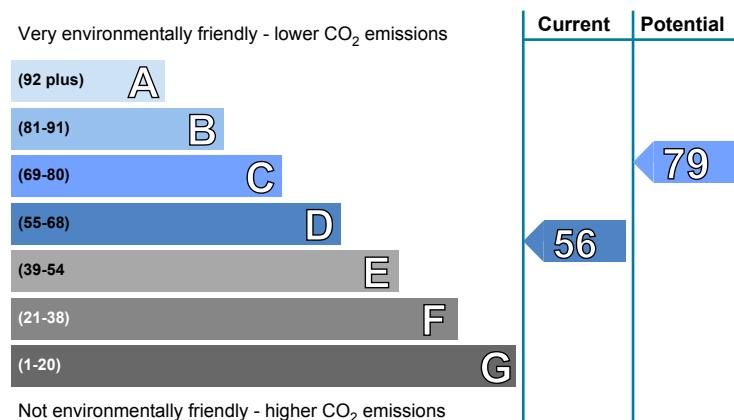
Environmental Impact (CO₂) Rating

This graph shows the effect of your home on the environment in terms of carbon dioxide (CO₂) emissions. The higher the rating, the less impact it has on the environment.

Your current rating is **band D (56)**. The average rating for EPCs in Scotland is **band D (59)**.

The potential rating shows the effect of undertaking all of the improvement measures listed within your recommendations report.
