Home Report

75 MERRYVALE AVENUE
GIFFNOCK
GLASGOW
G46 6DE

Walker Fraser Steele
Chartered Surveyors

75 MERRYVALE AVENUE, GIFFNOCK, GLASGOW, G46 6DE

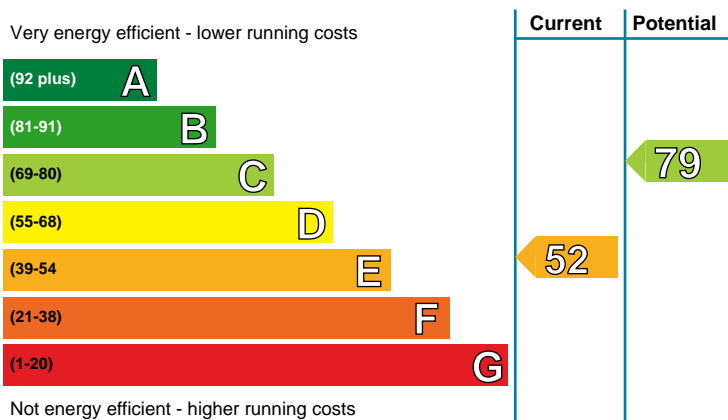
Energy Efficiency Rating

This graph shows the current efficiency of your home, taking into account both energy efficiency and fuel costs. The higher this rating, the lower your fuel bills are likely to be.

Your current rating is **band E (52)**. The average rating for EPCs in Scotland is **band D (61)**.

The potential rating shows the effect of undertaking all of the improvement measures listed within your recommendations report.

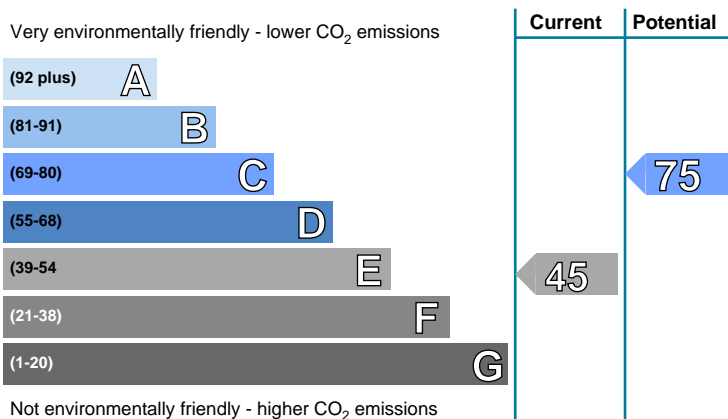
Environmental Impact (CO₂) Rating

This graph shows the effect of your home on the environment in terms of carbon dioxide (CO₂) emissions. The higher the rating, the less impact it has on the environment.

Your current rating is **band E (45)**. The average rating for EPCs in Scotland is **band D (59)**.

The potential rating shows the effect of undertaking all of the improvement measures listed within your recommendations report.

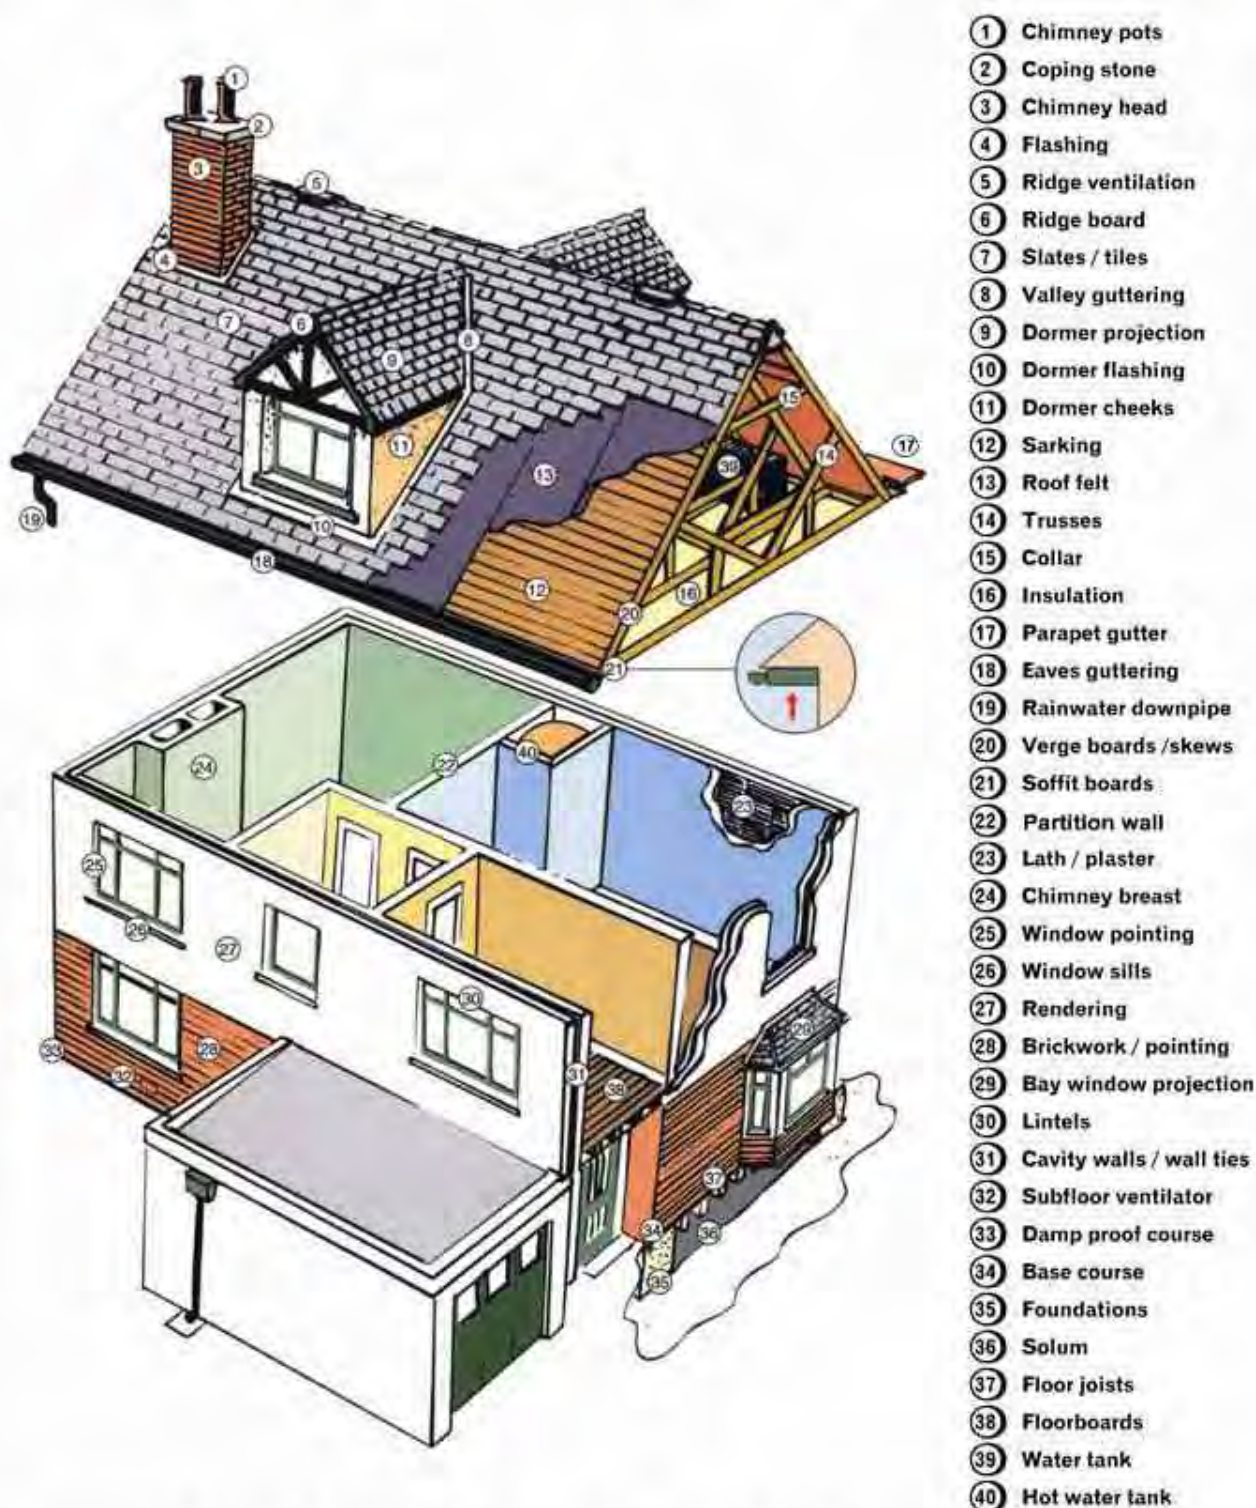
Sectional Diagram showing elements of a typical house

Reference may be made in this report to some or all of the above component parts of the property. This diagram may assist you in locating and understanding these items.
