HARVEY DONALDSON & GIBSON

Survey report on:

Property Address	40 Blacader Drive Gartcosh Glasgow G69 8DG
Customer	Miss N Sarvar
Date of Inspection	09/12/2024
Prepared by	Darren Nouillan Harvey Donaldson & Gibson Chartered Surveyors

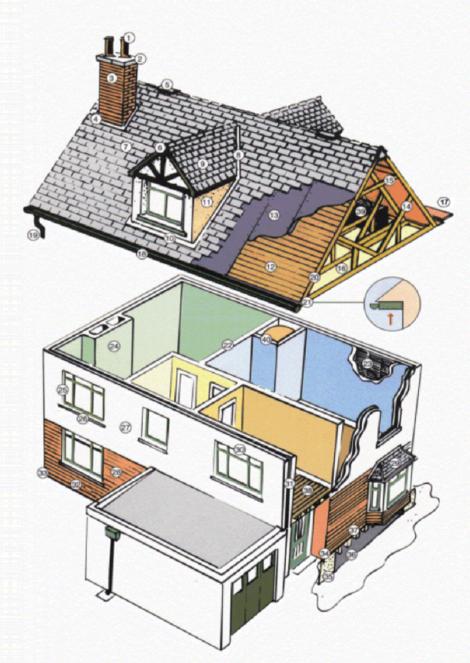
Sectional Diagram showing elements of a typical house

Reference may be made in this report to some or all of the above component parts of the property. This diagram may assist you in locating and understanding these items.

- **Chimney pots**
- Coping stone
- Chimney head
- Flashing
- Ridge ventilation
- 6 Ridge board
- 7 Slates / tiles
- 8 Valley guttering
- 9 Dormer projection
- 10 Dormer flashing
- **Dormer cheeks**
- 12 Sarking
- 13) Roof felt
- (14) Trusses
- (15) Collar
- 16 Insulation
- 17) Parapet gutter
- (18) Eaves guttering
- Rainwater downpipe
- 20 Verge boards /skews
- (21) Soffit boards
- (22) Partition wall
- 23) Lath / plaster
- 24) Chimney breast
- 25) Window pointing
- (26) Window sills
- (27) Rendering
- Brickwork / pointing
- 29 Bay window projection
- (30) Lintels
- 31) Cavity walls / wall ties
- 32) Subfloor ventilator
- 33 Damp proof course
- 34) Base course
- 35) Foundations
- (36) Solum
- 37) Floor joists
- 38) Floorboards
- (39) Water tank
- (40) Hot water tank
