# HOME REPORT

127 GLENCROFT ROAD  
GLASGOW  
G44 5RN

# Energy Performance Certificate (EPC)

# Single Survey

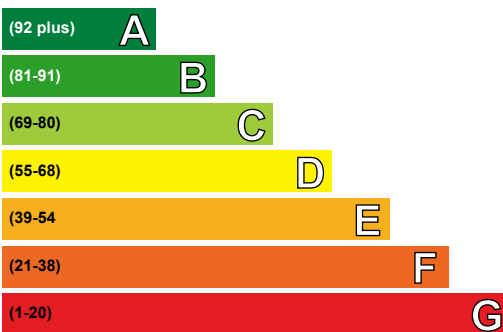
## Energy Efficiency Rating

This graph shows the current efficiency of your home, taking into account both energy efficiency and fuel costs. The higher this rating, the lower your fuel bills are likely to be.

Your current rating is **band C (72)**. The average rating for EPCs in Scotland is **band D (61)**.

The potential rating shows the effect of undertaking all of the improvement measures listed within your recommendations report.
