Home Report

25 MILL ROAD
HAMILTON
ML3 8AA

Walker Fraser Steele
Chartered Surveyors

Energy Performance Certificate (EPC)

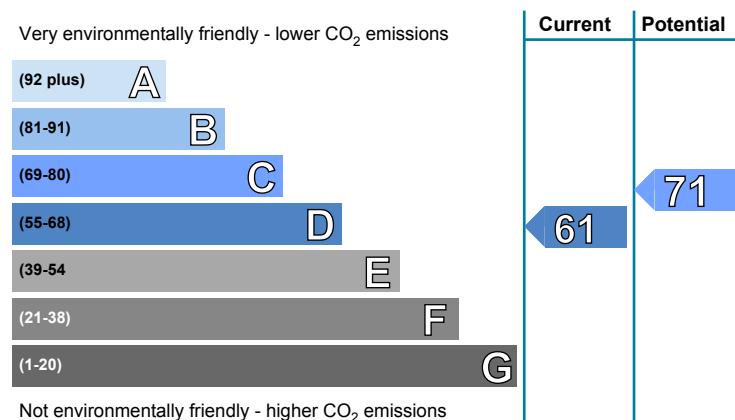
Environmental Impact (CO₂) Rating

This graph shows the effect of your home on the environment in terms of carbon dioxide (CO₂) emissions. The higher the rating, the less impact it has on the environment.

Your current rating is **band D (61)**

The potential rating shows the effect of undertaking all of the improvement measures listed within your recommendations report.
