Home Report

Walker Fraser Steele
Chartered Surveyors

Single Survey

Property Address	Flat 0/1 9 Florida Street Glasgow Glasgow G42 9DW
Customer	Mrs Diane Bulloch
Date of Inspection	16/03/2026
Prepared by	Alan Hudson Walker Fraser Steele

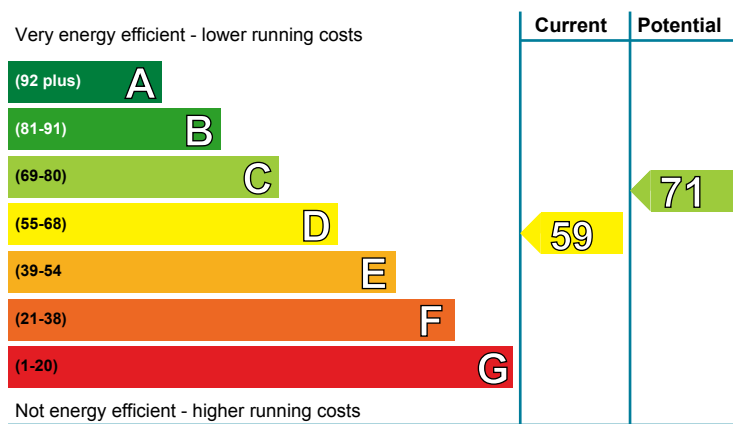
Energy Efficiency Rating

This graph shows the current efficiency of your home, taking into account both energy efficiency and fuel costs. The higher this rating, the lower your fuel bills are likely to be.

Your current rating is **band D (59)**. The average rating for EPCs in Scotland is **band D (61)**.

The potential rating shows the effect of undertaking all of the improvement measures listed within your recommendations report.
