# Home Report

FLAT 2/2  
27 CARTVALE ROAD  
GLASGOW  
G42 9TA

**Walker Fraser Steele  
Chartered Surveyors**

FLAT 2/2, 27 CARTVALE ROAD, GLASGOW, G42 9TA

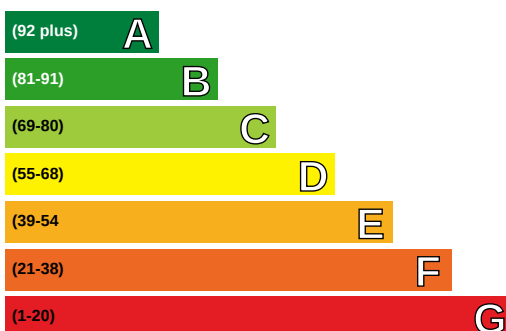
## Energy Efficiency Rating

This graph shows the current efficiency of your home, taking into account both energy efficiency and fuel costs. The higher this rating, the lower your fuel bills are likely to be.

Your current rating is **band D (66)**. The average rating for EPCs in Scotland is **band D (61)**.

The potential rating shows the effect of undertaking all of the improvement measures listed within your recommendations report.

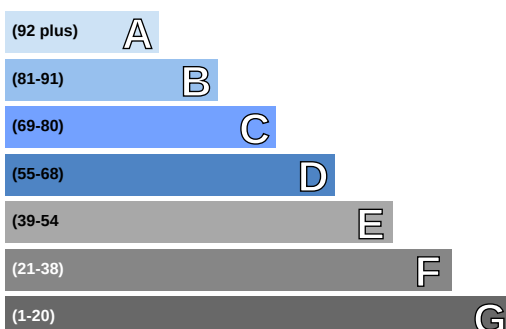
Very environmentally friendly - lower CO<sub>2</sub> emissions

Not environmentally friendly - higher CO<sub>2</sub> emissions

The potential rating shows the effect of undertaking all of the improvement measures listed within your recommendations report.

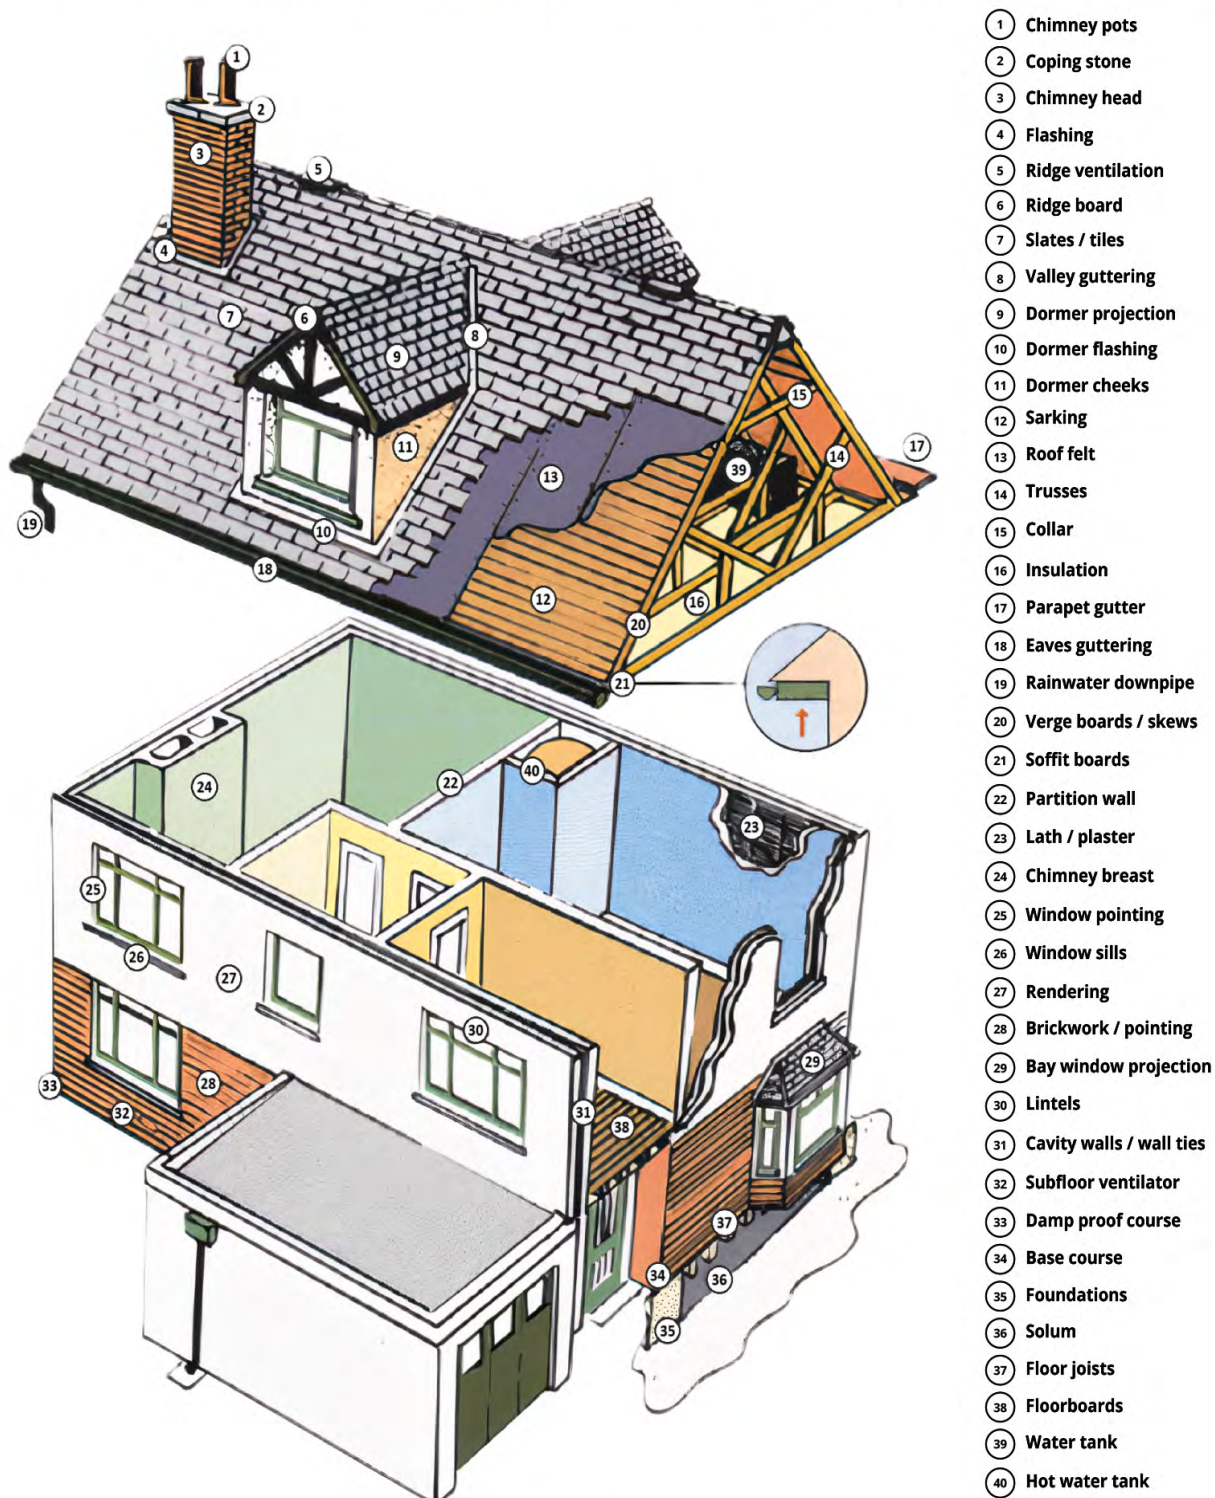
## Sectional Diagram showing elements of a typical house

Reference may be made in this report to some or all of the above component parts of the property. This diagram may assist you in locating and understanding these items.
